Tech Talk
March 21, 2013
Mod 78 Spar to Aileron
Crosslink Rod and Forward Socket Clearance Issues

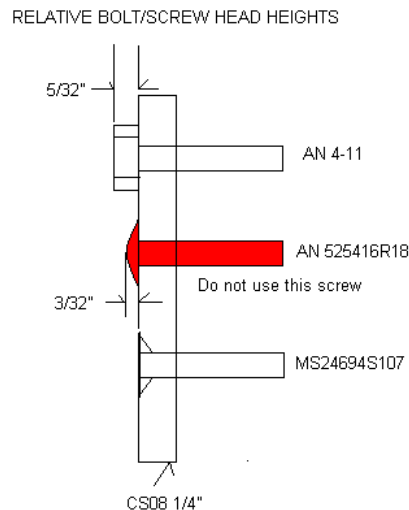
In our Mod 78 installations in the shop, even with careful width control on the spar bid layups, we have experienced unacceptable clearance or contact between the bolt heads of the CS08 to the spar due to builder variances. If the cockpit module was installed slightly askew, or the builder moved his bearings and supports for his aileron CS08 arms forward of the three inches just a bit, or the tapes around the CS14 and module at the fuselage spar hole had a lot of flox, or the CS08 arms were not bent sufficiently (most are consistent but can be as far off as 1/8 inch from one another) then we will typically have a clearance issue of about 1/16 to 1/8 inch that builders will call us on...

It is clear that the AN4 style head at 5/32nds inch head height needs to be addressed. The casual observer would consider use of an AN 525416R18 washer head screw in place of the AN4-11. The 525 washer head is lower by about 1/16 inch, but the head is not designed for pull tension and is unacceptable. The alternative is to use a countersunk structural screw such as the MS24694S107. The 100 degree countersink is quite strong and since the CS08 is 1/4 inch thick, the use of this screw would be a good work around. The CS08 is tempered aluminum is quite tough. Also, it is impossible to use existing countersink tools to do the job in place. We have devised an adaption for our close quarter drill head to allow use of a 1/4 inch by 100 degree countersink to get a true flat and precise fit. This is expensive and not for the amateur.

In the event there is a clearance problems using the AN4-11 bolts remove the CS08 and countersink the CS08 for the MS24694S107 countersunk screws. Removal of the CS08 would involve the following:

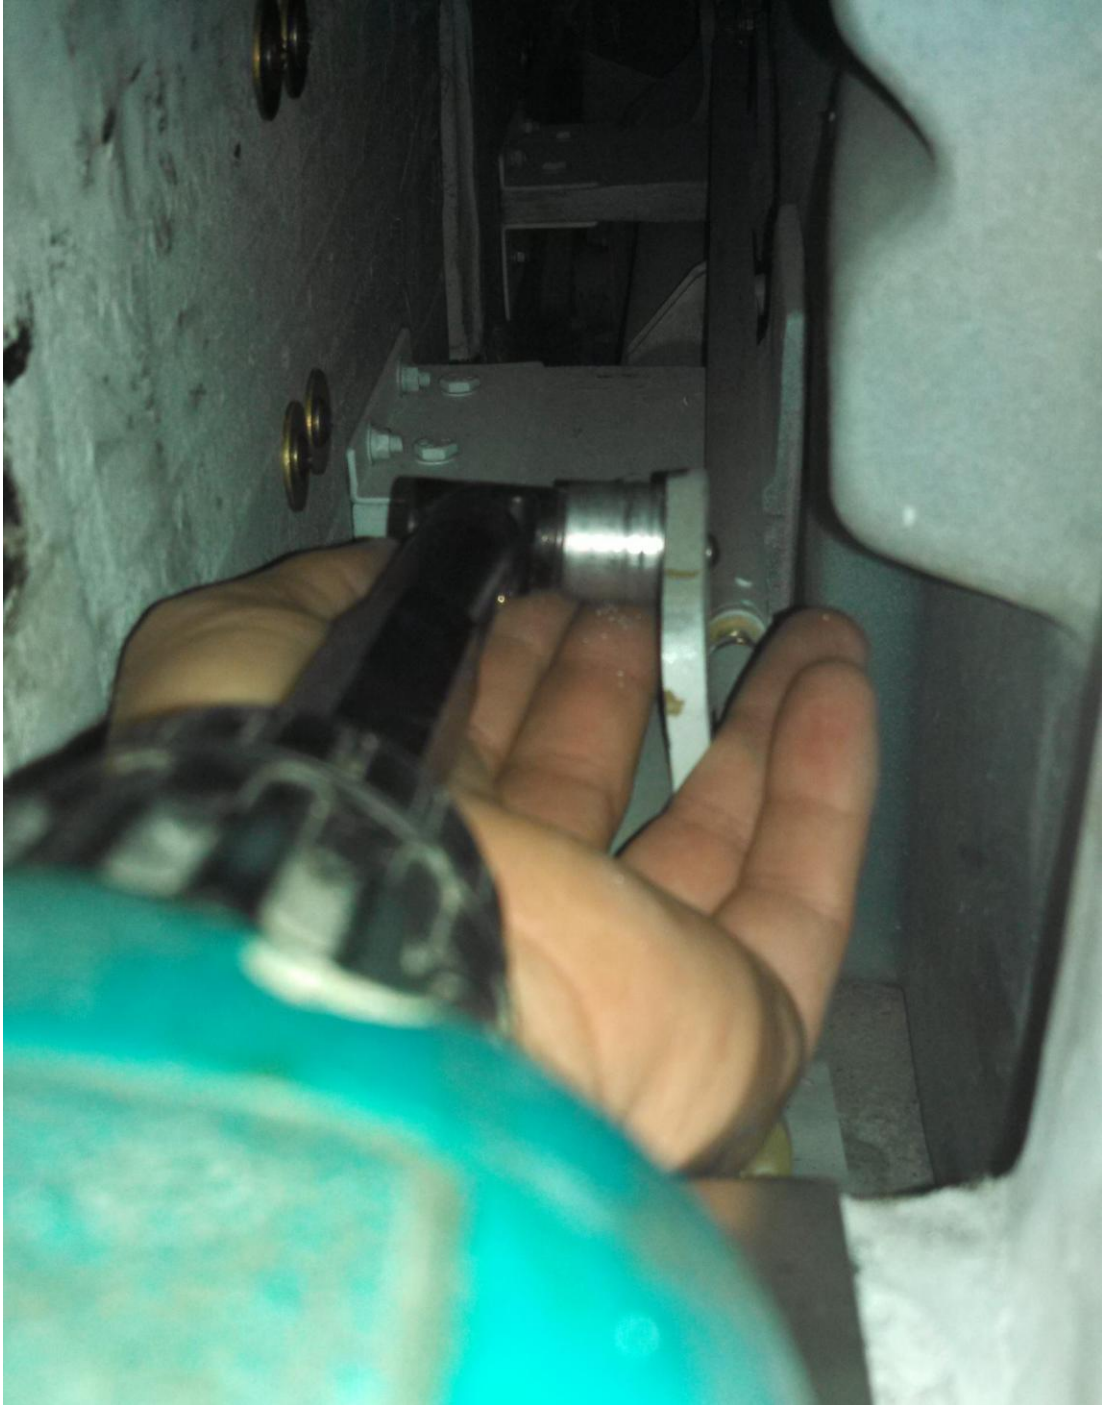
As can be seen in the photo above, clearance is tight but the spacer keeps the head flat against the aluminum and the pilot of the bit does the rest of the work.

Simply make from aluminum 1 inch tube (as used in the aileron lateral push rods) a spacer for a tight angle drill. Be sure to make your spacer absolutely square.

The drill pilot will keep your drilling relatively straight, but to get the countersink dead square, some sort of stop is essential. A micro stop mini will not work in most cases.

Check the countersink for proper depth. Do not over countersink. Install the MS24694S107 structural screws. Reassemble the cross rod and enjoy the extra clearance.

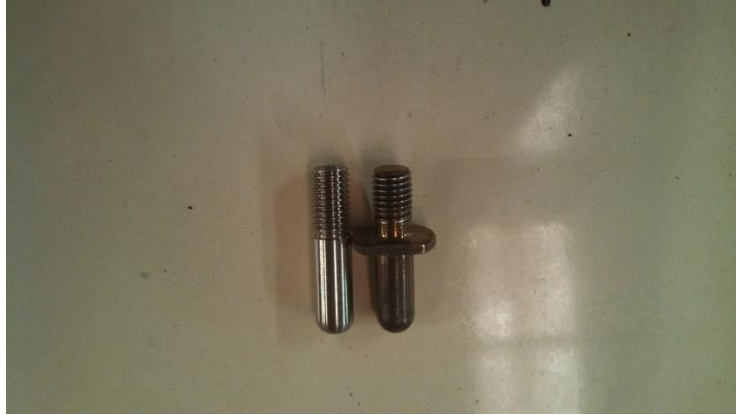
This is a long awaited improvement to the front wing lift socket. It is substantially stronger and will be stiffer and incorporates a bearing, similar to the flap bearing, to allow for pin alignment during rigging if you didn't quite get things straight drilling and threading in your lift pins. The new socket is now slightly shorter than the existing socket to allow for clearance issues and for the new pin with a machined flange for wrenching it on. See pin photo:

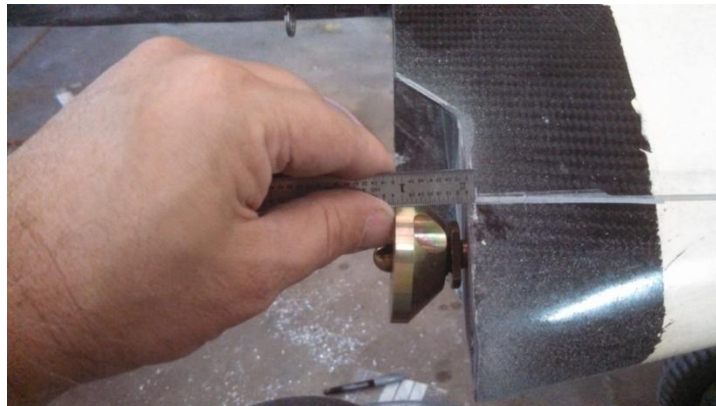
On a new build, the sockets should be straight forward to install. On a previously rigged aircraft, carefully mark around the new socket and remove paint and filler for a good bonding surface. In our experience, the left socket is nearly butted right against the root rib. If the cockpit module was installed askew or for other reasons, we have seen the left forward socket filed down to clear the rib for proper wing sweep alignment, so there may be fit problems using the new pin. To accommodate this, the new socket is shorter than the previous model. However the new pin flange may still be a problem. See the photo below:

If you find yourself with the problem above and are concerned with clearance, remember that the additional root glass layups will fill this void between the root and pin flange. However, if clearance is still tight between the root and socket, contact tech support and we will supply a non flanged pin.
